Drysdale, Montgomery and Bailey Creek Bridge Environmental Assessment County of Simcoe

In 2005, the County of Simcoe retained the Ainley Group to undertake a Class Environmental Assessment (EA), Schedule 'B', of three bridges. The Class EA study will confirm the need for improvements and whether replacement is the most appropriate solution for each bridge. The study area at each site extends out from each side of the structure to provide sufficient roadway to reconstruct the bridge approaches if necessary. Additionally, the study area also extends approximately 100 metres upstream and downstream from each bridge to assist the stormwater (hydrology and hydraulic) design of a new structure. If the EAs recommend replacement as the best option, construction will be scheduled for the summer of 2007.

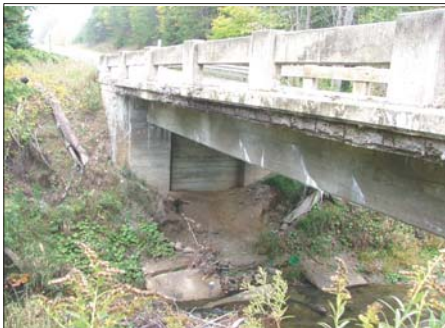
Drysdale Bridge

Bridge No. 056080 (Drysdale Bridge) located on County Road No. 56 – a single-span structure with a deck length of 21.32 metres and a deck width of 7.32 metres constructed in 1950. A visual inspection of the bridge confirmed that the deck and girders were heavily cracked and spalled with evidence of leakage as noted by the significant quantity of efflorescence on the underside of the superstructure. The current barriers, a concrete post and rail system with steel-beam guardrail approaches, are in very poor condition. It was also determined that a new structure design must address problems associated with the current road profile over and approaching the bridge.

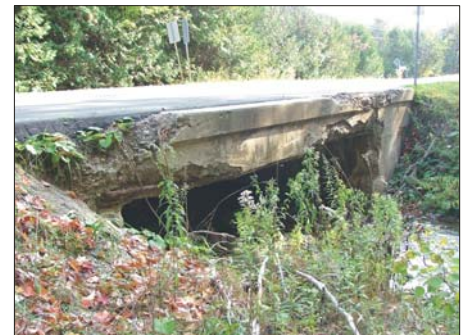
Montgomery Bridge

Bridge No. 009235 (Montgomery Bridge) located on County Road No. 9 – a reinforced concrete rigid frame with a deck length of 10.97 metres and a deck width of 8.36 metres constructed in 1929. A visual inspection of the bridge confirmed that the structure was in very poor condition with numerous large cracks and spalls with corroded reinforcing steel visible on the fascias, soffit and wingwalls. In addition, there were no barriers on the bridge or approaches, contrary to the current Canadian Highway Bridge Design Code and the Ministry of Transportation's Roadside Safety Manual. Considering the condition of the bridge, it was determined that rehabilitation of the structure would not be economical.

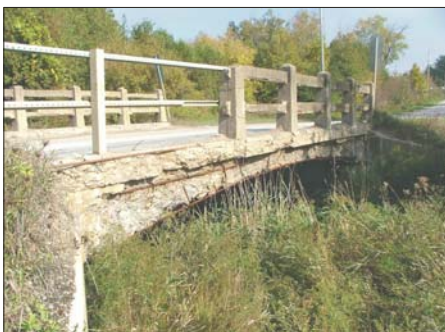
Bailey Creek Bridge

Bridge No. 014075 (Bailey Creek Bridge) located on Adjala-Tosoronto Sideroad 10 – a reinforced concrete rigid frame with a deck length of 10.67 metres and width of 6.45 metres constructed in 1935. A visual inspection of the bridge confirmed that the structure was in very poor condition with numerous large cracks and spalls with corroded reinforcing steel visible on the fascias and soffit. In addition, the existing barriers were found to be non functional and in extremely poor condition, with a large portion of the south barrier missing completely. The existing barriers would not meet the performance requirements of the current Canadian Highway Bridge Design Code.
