## Black Ash Creek Flood Control – Phase III

## The Project – Phase III

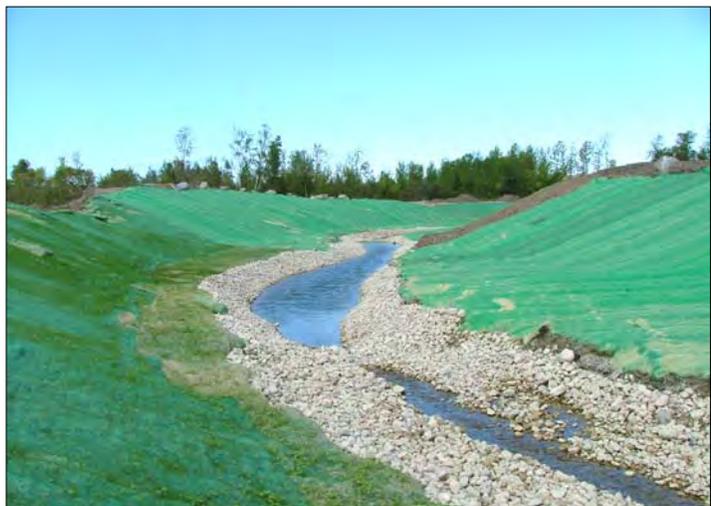
*A completed section of Phase III of the Black Ash Creek Flood Control Project showing the seed and erosion control blankets on the side slopes.*

With floodway side slopes being approximately 10 to 12 metres in length, the revegetation efforts were concentrated within the bottom 2.0 to 2.5 metres of the banks and along top-of-bank areas. All disturbed or exposed and erodible soils within the floodway were covered with approximately 15cm of topsoil, seeded with a typical road side grass mixture and overlaid with a heavy-grade biodegradable geotextile.

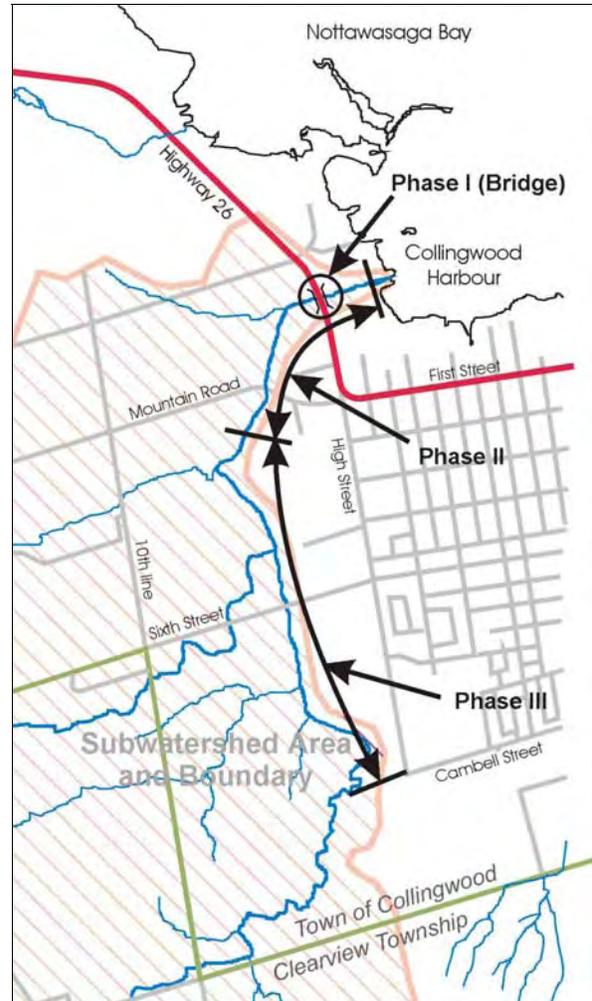
*The map above shows the three phases of the Black Ash Creek Flood Control Project.*

The Black Ash Creek Flood Control project was undertaken in three phases.

**Phase 1:** The replacement of the Highway 26 Bridge over Black Ash Creek - a project undertaken by the Ainley Group in 1996.

**Phase 2:** The channelization of Black Ash Creek from a point near the Collingwood Harbour, extending upstream under the Highway 26 Bridge for 1.4 kilometres - completed in the spring of 2004.

**Phase 3:** The continued channelization of Black Ash Creek upstream for another 2.5 kilometres - substantial completion reached in June of 2005.

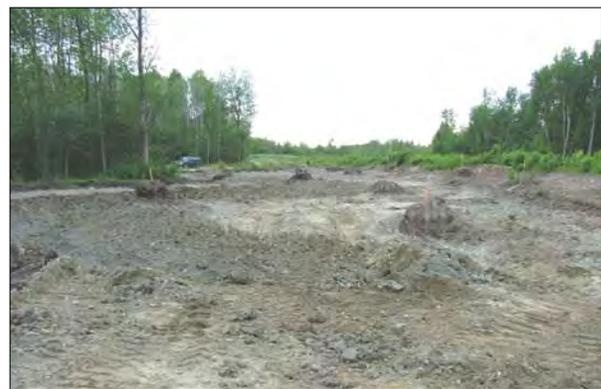
*Initial clearing of the work site.*

After the contract was awarded in November of 2003, initial clearing of the site began and was completed before the start of winter. In addition to the clearing operation, a 40-metre extension was added to the existing multi-plate steel culvert at the Sixth Street Bridge location. The culvert extension was added in preparation for the construction of a two-lane temporary detour in the following year and a new bridge.

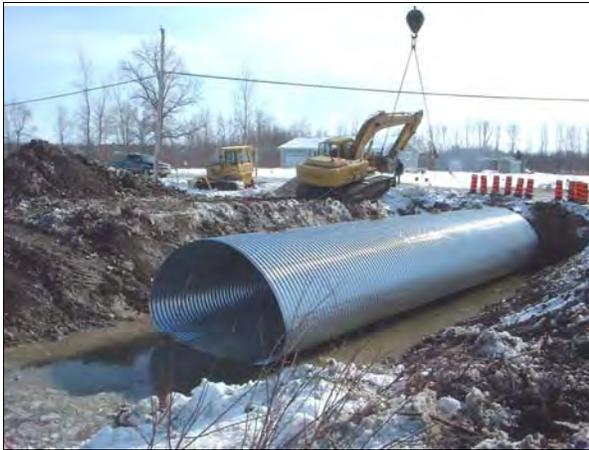
*Positioning the multi-plate steel culvert extension.*

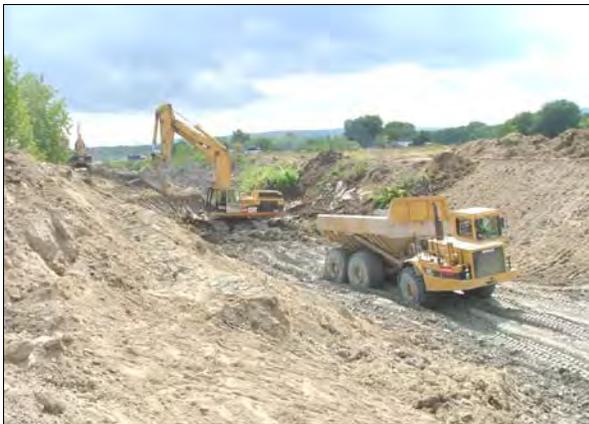
*Heavy equipment beginning the excavations for the channelization of the creek in the spring of 2004.*

In the spring of 2004, major excavation began on the section of the creek bed that was to have a new alignment. Care was taken to ensure the existing creek was not disturbed while excavating.

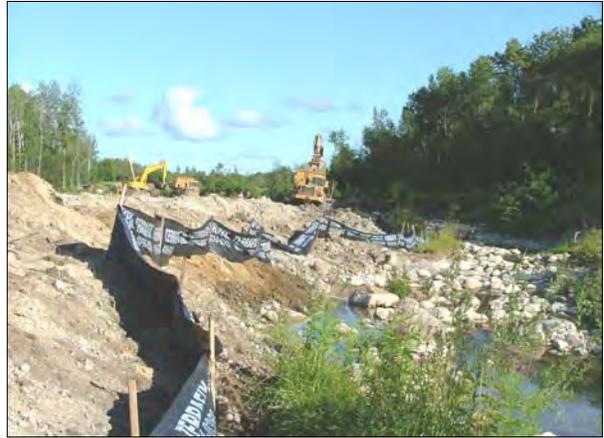
*The existing creek bed (at the right) was protected while construction of the new alignment continued.*

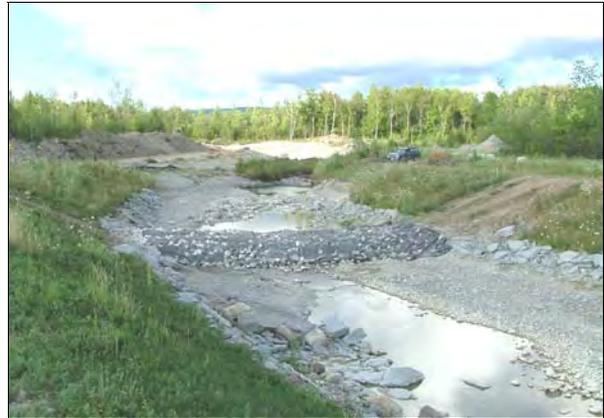
*A silt cofferdam was constructed at the upstream limit of Phase II to prevent sediment migration.*

- All in-stream work to be completed in the dry by dewatering the work area and diverting and/or pumping flows around cofferdams placed at the limits of the work area.

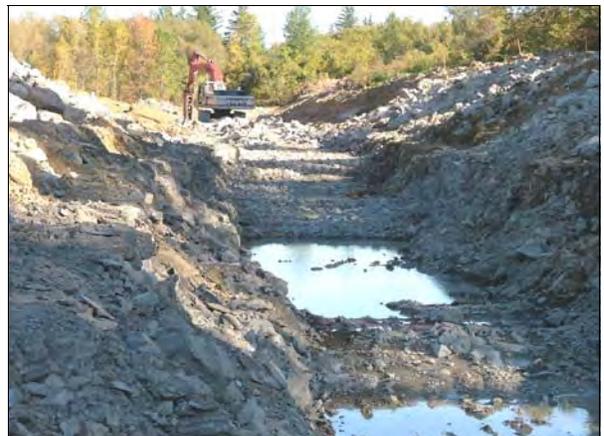
*Rock excavation for the new channel alignment.*

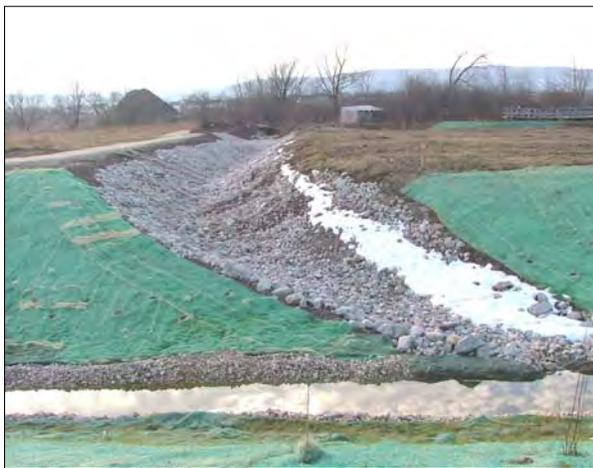
*A weir was constructed at the original merging point of the Petun to divert flow into the new stream bed.*

A series of fish habitat features were constructed at specific points along the newly channelized creek bed. These features were designed to aid fish in their upstream travel during the annual spawning period. Earth and rock excavation from the site was used to construct the pools and riffles, fish ladder boulder clusters and live-rock revetments at the outside of bends of pools and rocky ramps. Imported river stone of 50 to 200-mm in size was placed in the constructed pools and riffles to a depth indicated on the drawings. During construction of the main channel, some fish habitat was lost. As compensation, a new meandering stream was created by diverting the merging point of the Petun branch to run parallel with the main channel for approximately 500 metres before entering. The newly created stream bed, constructed on land owned by the NVCA, is designed for a 2-year event level. A weir was constructed at the original merging point of the Petun to divert excess flow, at times of high run off and storm events, into the main channel.

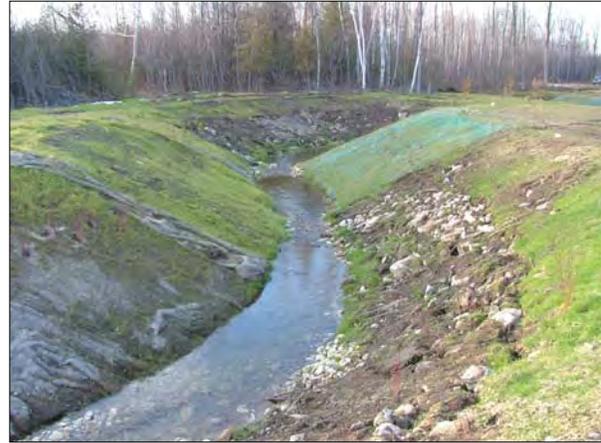
*A completed section of the new Petun branch meandering stream bed, which parallels the main channel for 500 metres*

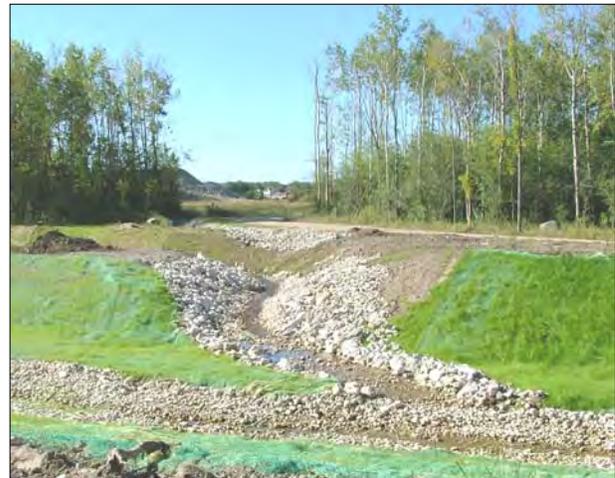
*The Petun branch outletting into the main channel*

The section of Black Ash Creek contained within the Phase III limits has several feeder streams that outlet into the main channel. Each of these water sources had to be properly sculptured and aligned with the main channel to avoid potential erosion during spring run off or storm events. Side slope contouring and placement of rip rap, erosion blankets and rock revetments were employed at each inlet point.

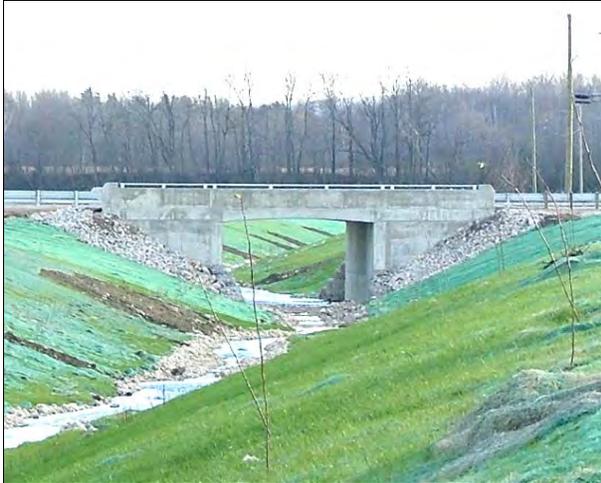
*The completed Sixth Street Bridge*

After the two-lane temporary detour was built over the culvert extension the excavation for the bridge began. Prior to tendering Black Ash Creek Phase III, it was decided to change the cross section of the structure to allow for future widening of 6<sup>th</sup> Street from two lanes to four lanes based on future traffic volumes.

With the added width incorporated into the design, a temporary concrete wall was constructed on the downstream (north) side of the bridge giving a three-metre wide pathway for the Georgian Trail until the road is widened.

Since the bridge is an integral part of the Black Ash Creek Channelization project, particular care

was given to the placement of rip rap scour protection at the inlet and outlet of the structure, the location of geotextile fabric under the rip rap and the placement and compaction of backfill in the excavated area.

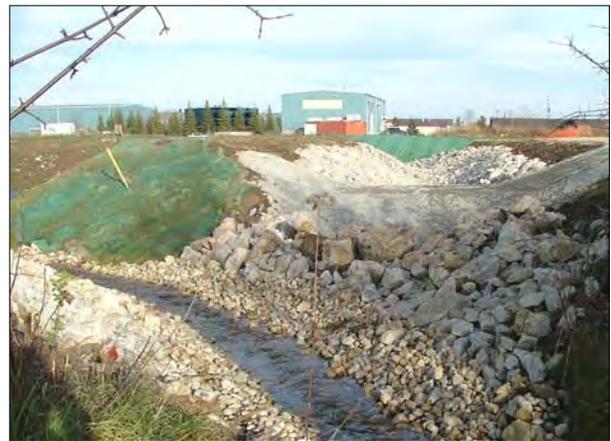
*This photo shows one of the rock revetments, completed slopes and landscaping.*

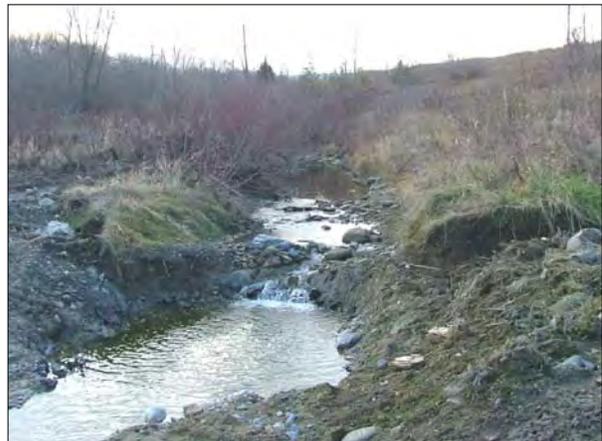
*At the southern limits of the channelization project, the creek reverts back to its natural flow.*
