Black Ash Creek Flood Control – Phase III

The Project – Phase III

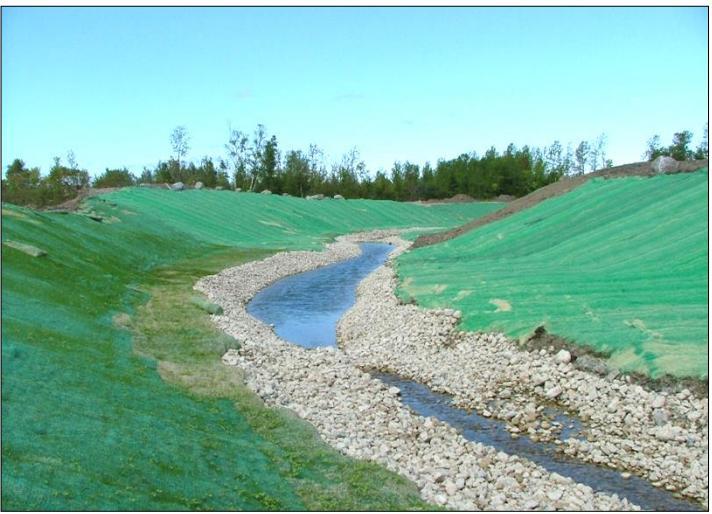
A completed section of Phase III of the Black Ash Creek Flood Control Project showing the seed and erosion control blankets on the side sloves.

With floodway side slopes being approximately 10 to 12 metres in length, the revegetation efforts were concentrated within the bottom 2.0 to 2.5 metres of the banks and along top-of-bank areas. All disturbed or exposed and erodible soils within the floodway were covered with approximately 15cm of topsoil, seeded with a typical road side grass mixture and overlaid with a heavy-grade biodegradable geotextile.

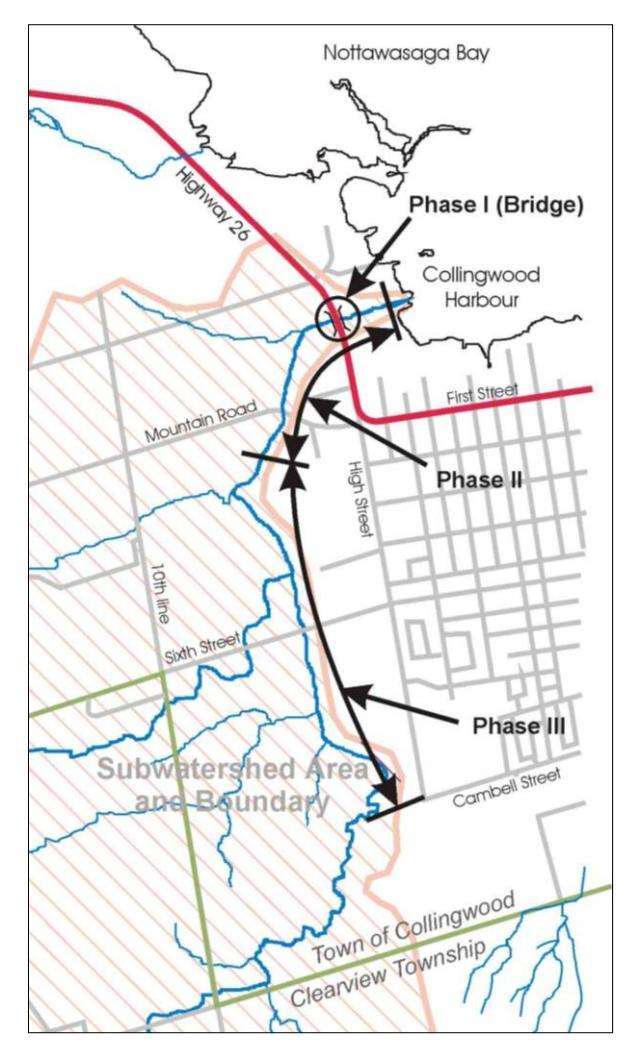
The map above shows the three phases of the Black Ash Creek Flood Control Project.

- **Phase 1:** The replacement of the Highway 26 Bridge over Black Ash Creek - a project undertaken by the Ainley Group in 1996.
- **Phase 2:** The channelization of Black Ash Creek from a point near the Collingwood Harbour, extending upstream under the Highway 26 Bridge for 1.4 kilometres completed in the spring of 2004.
- **Phase 3:** The continued channelization of Black Ash Creek upstream for another 2.5 kilometres - substantial completion reached in June of 2005.

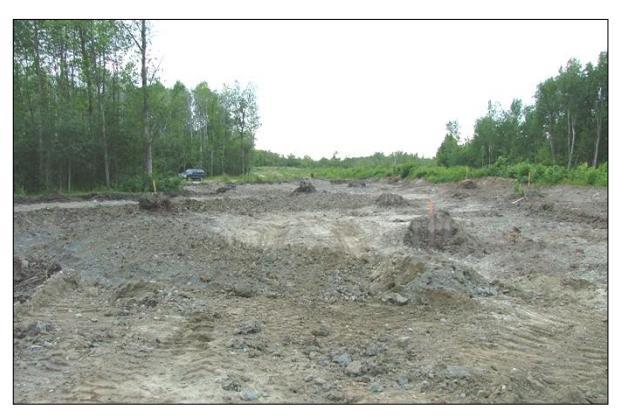
Initial clearing of the work site.

After the contract was awarded in November of 2003, initial clearing of the site began and was completed before the start of winter. In addition to the clearing operation, a 40-metre extension was added to the existing multi-plate steel culvert at the Sixth Street Bridge location. The culvert extension was added in preparation for the construction of a two-lane temporary detour in the following year and a new bridge.

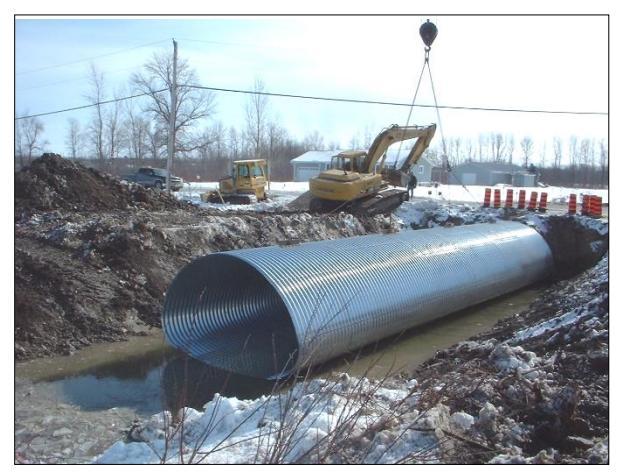
Positioning the multi-plate steel culvert extension.

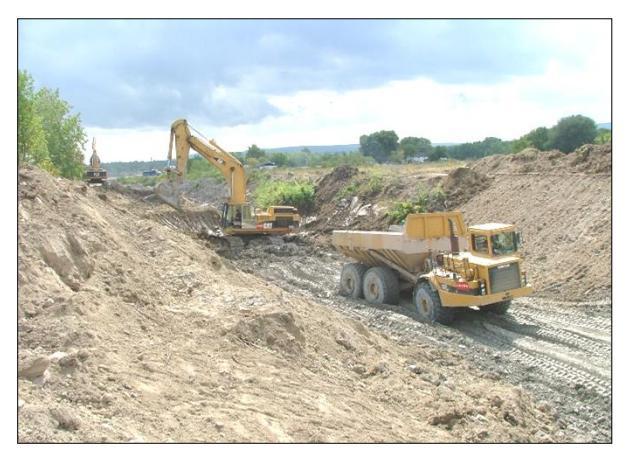
Heavy equipment beginning the excavations for the channelization of the creek in the spring of 2004.

In the spring of 2004, major excavation began on the section of the creek bed that was to have a new alignment. Care was taken to ensure the existing creek was not disturbed while excavating.

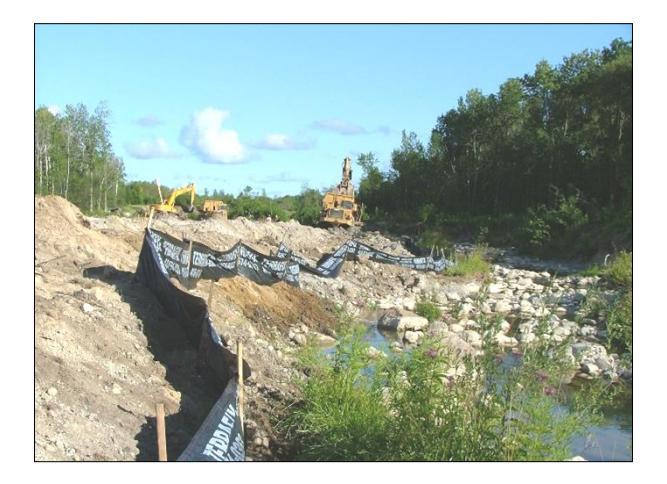
The existing creek bed (at the right) was protected while construction of the new alignment continued.

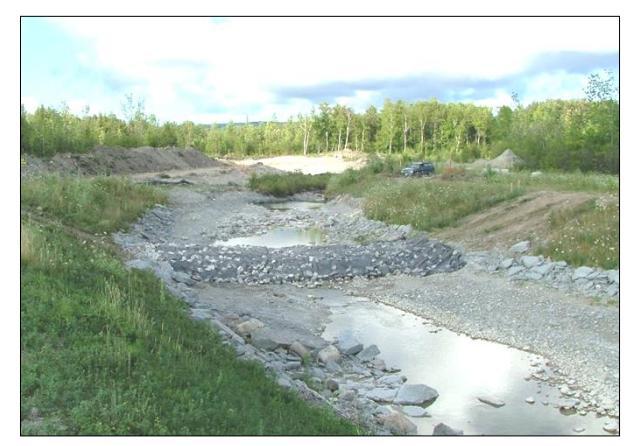
A silt cofferdam was constructed at the upstream limit of Phase II to prevent sediment migration.

All in-stream work to be completed in the dry by dewatering the work area and diverting and/or pumping flows around cofferdams placed at the limits of the work area.

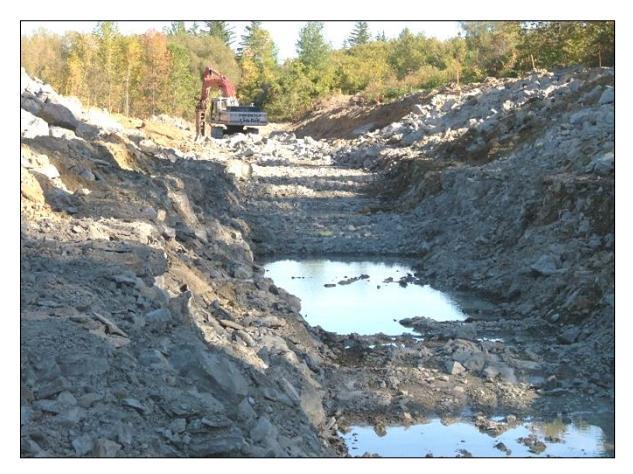
Rock excavation for the new channel alignment.

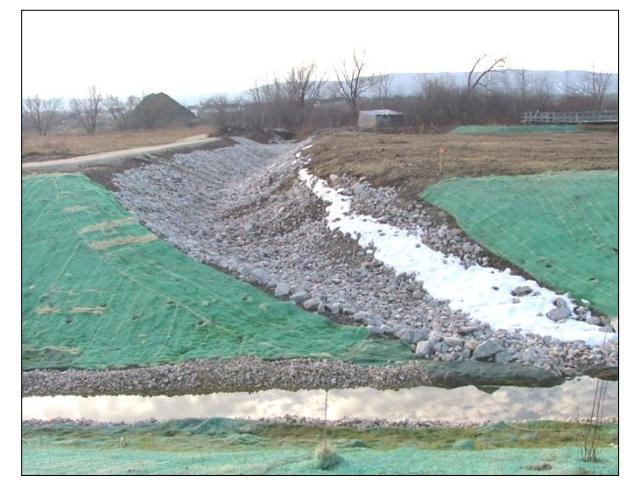
A weir was constructed at the original merging point of the Petun to divert flow into the new stream bed.

During construction of the main channel, some fish habitat was lost. As compensation, a new meandering stream was created by diverting the merging point of the Petun branch to run parallel with the main channel for approximately 500 metres before entering. The newly created stream bed, constructed on land owned by the NVCA, is designed for a 2-year event level. A weir was constructed at the original merging point of the Petun to divert excess flow, at times of high run off and storm events, into the main channel.

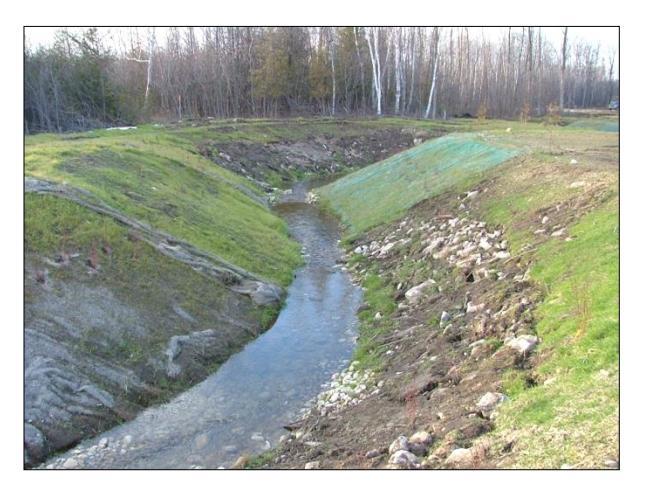
A completed section of the new Petun branch meandering stream bed, which parallels the main channel for 500 metres

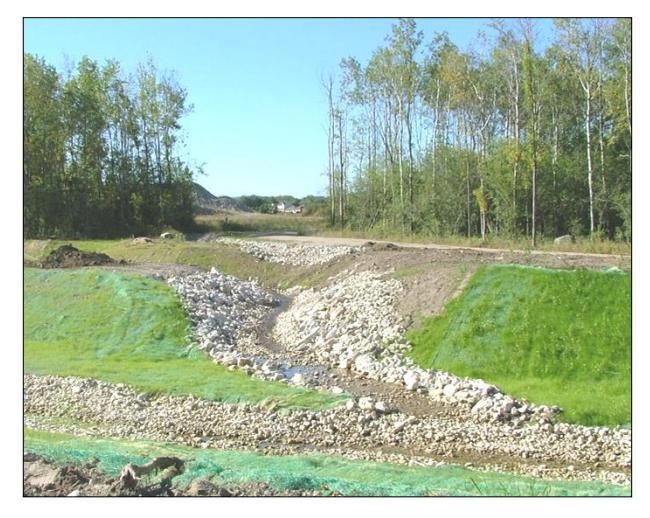
The Petun branch out letting into the main channel

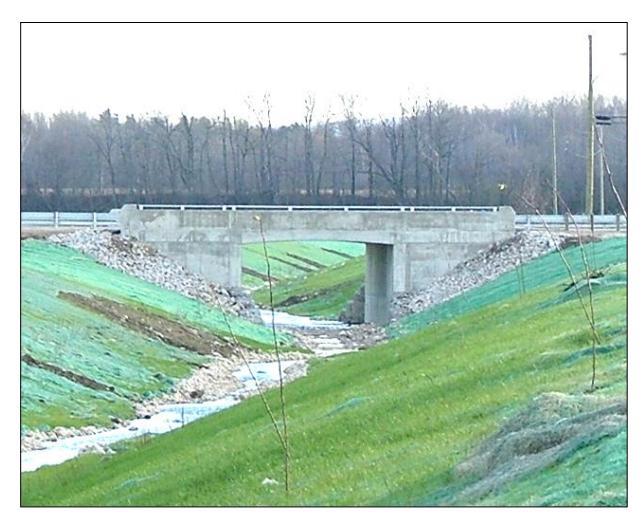
The completed Sixth Street Bridge

After the two-lane temporary detour was built over the culvert extension the excavation for the bridge began. Prior to tendering Black Ash Creek Phase III, it was decided to change the cross section of the structure to allow for future widening of 6th Street from two lanes to four lanes based on future traffic volumes.

With the added width incorporated into the design, a temporary concrete wall was constructed on the downstream (north) side of the bridge giving a three-metre wide pathway for the Georgian Trail until the road is widened.

Since the bridge is an integral part of the Black Ash Creek Channelization project, particular care was given to the placement of rip rap scour protection at the inlet and outlet of the structure, the location of geotextile fabric under the rip rap and the placement and compaction of backfill in the excavated area.

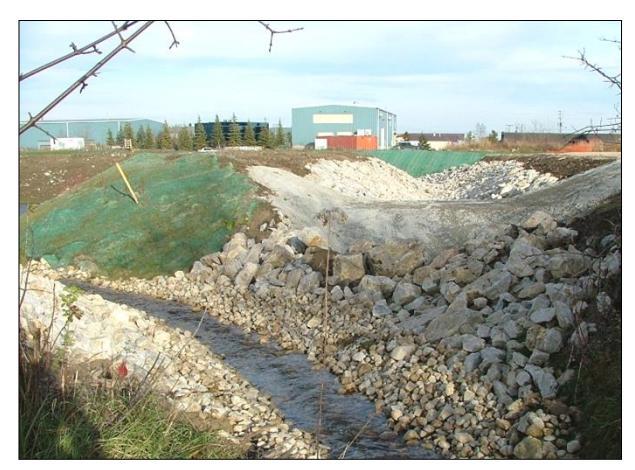
This photo shows one of the rock revetments, completed slopes and landscaping.

The section of Black Ash Creek contained within the Phase III limits has several feeder streams that outlet into the main channel. Each of these water sources had to be properly sculptured and aligned with the main channel to avoid potential erosion during spring run off or storm events. Side slope contouring and placement of rip rap, erosion blankets and rock revetments were employed at each inlet point.
