James Avenue Bridge Rehabilitation Town of Wasaga Beach

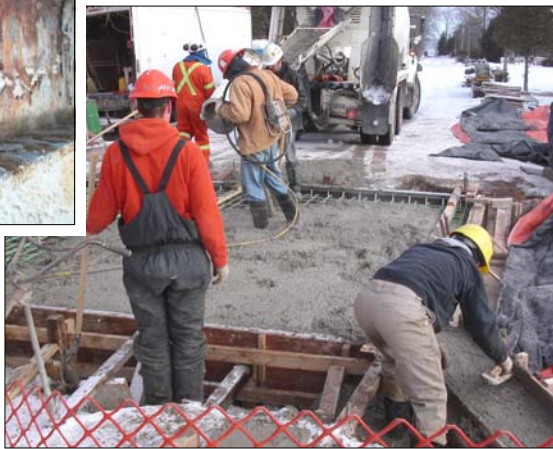
Due to the extensive corrosion of the beam webs, it was determined that the superstructure required replacement.

In October 2004, the Town of Wasaga Beach retained the Ainley Group to undertake a condition appraisal of the James Avenue Bridge. The appraisal revealed that the timber deck was in very good condition, as were the concrete abutments, with only minor surface scaling and some honeycombing evident. The condition of the beams however varied, with some in fair shape while others were badly deteriorated with heavy corrosion and scaling of both their flanges and webs. Three of the beams had sections of their webs corroded completely away.

After completion of the bridge appraisal report, a load evaluation was completed and the structure was monitored over an eight (8) month period, from December 2004 to July 2005. During this time, the bridge was inspected periodically and observed under varying traffic loads with the condition of the beams recorded to determine the change in extent and rate of deterioration. During the evaluation period, a noticeable increase in the extent of deterioration of the steel beams was evident including an increase in the size of holes in the webs of three beams. The evaluation and monitoring results, combined with the initial appraisal report, confirmed that the beams were deficient to support full traffic loading and that the bridge superstructure should be replaced.

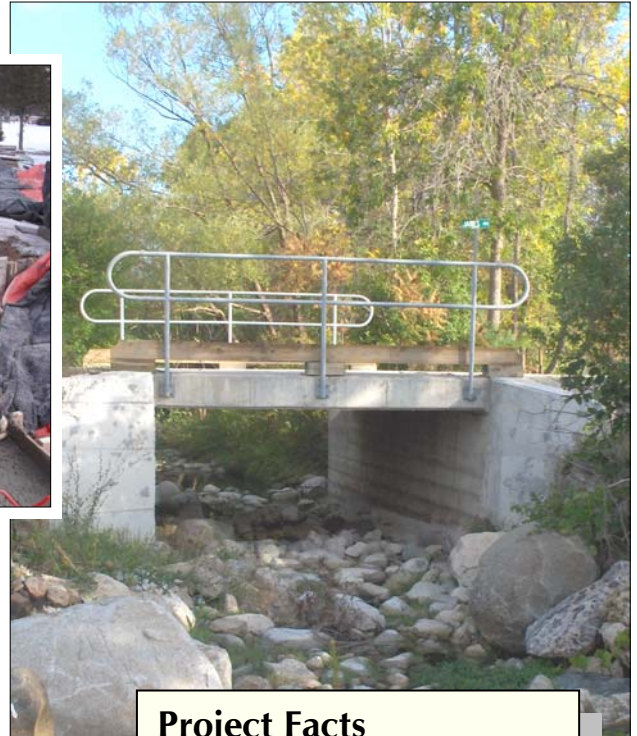
Pouring the deck – December 30, 2005.
